# Property Condition Report

## Prepared For: Commercial Sample

## Prepared By: Minnesota Building Inspections

**Date of Inspection:** 6/16/2017

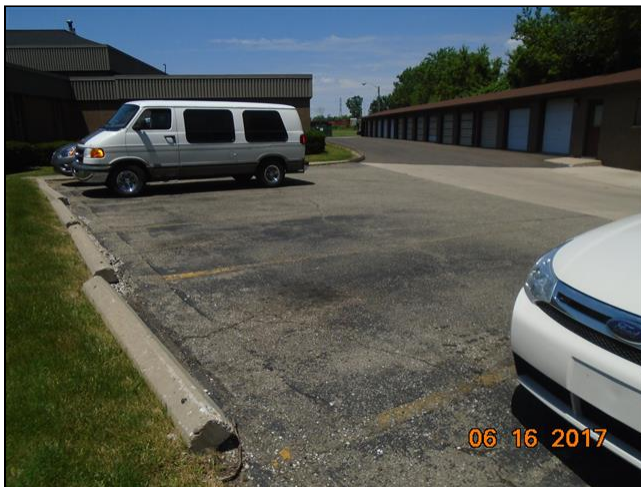
3.0 Item 9(Picture) Employee parking-only small areas  
of asphalt need repair

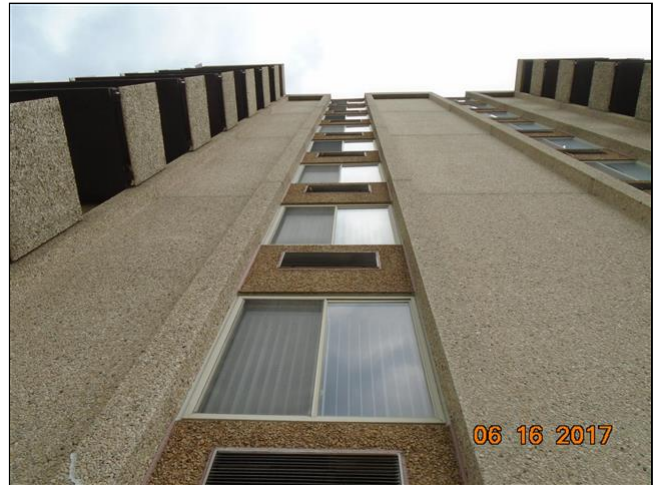
4.1 Item 2(Picture) Windows were very good

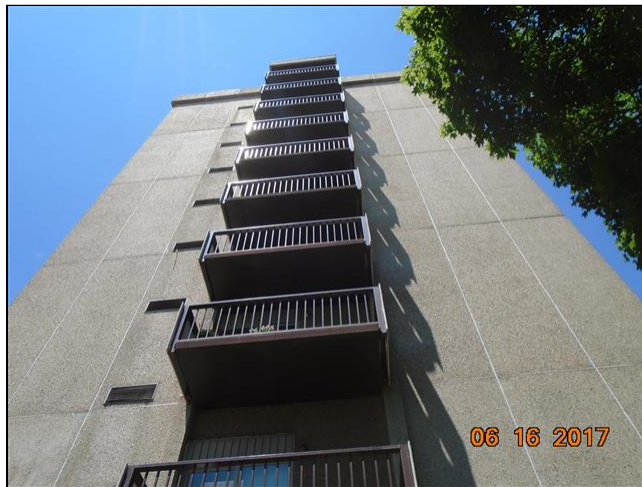
4.1 Item 3(Picture) Whole exterior building re-caulked. Structural cement panel deck floors

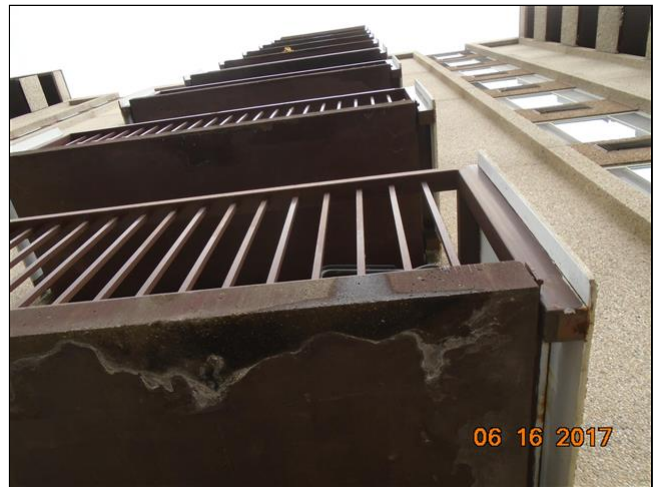
The decks are structural cement panels. There was some water staining-but no structural issues could be found.

4.1 Item 4(Picture) Decks are structural cement panels- There was some water staining-but no structural issues could be found.

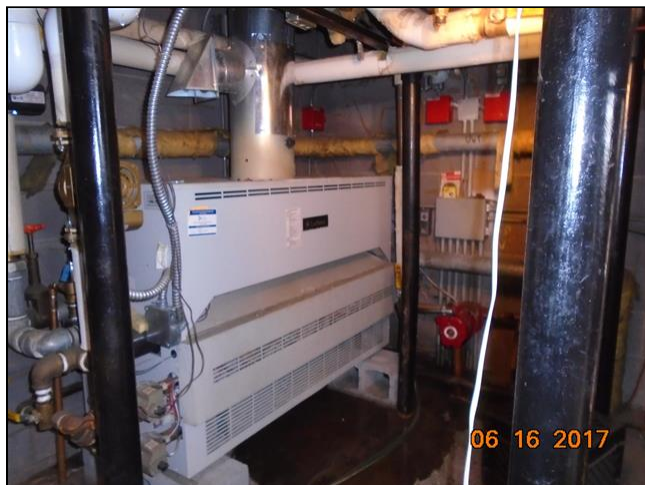
**CONCERNS:** There was water on the floor under one of the 2007 (10 year-old) boilers. Boilers are expected to operate up to 50+ years.

5.1 Item 1(Picture) Water on floor below Lochnivar boiler- needs service

**RECOMMENDATIONS:** Have both boilers serviced, and repair as needed.

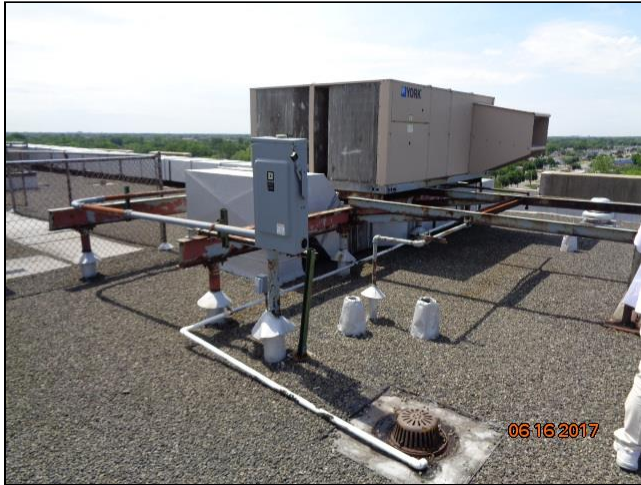
Two of the RTU's are 17 years old (an approximate 20 TON AHU, and 4 TON packaged heating/cooling unit). Two cooling condensers to the split-systems are 17 years or older (2 TON, and 2.5 TON). The average life of cooling components (compressor's, evaporator coils, condensers) are 16-23 years. Sometimes it is more cost effective to replace the whole system rather make costly repairs.

6.0 Item 1(Picture) York AHU for hallways 3-10

**RECOMMENDATIONS:** Budget for the replacement or repair of the 2003 York 20 TON rooftop AHU that conditions hallways 3-10. This may be \$40,000+ however, please obtain contractor quotes. There is one 2002-4 TON RTU, and two 2 TON condensers that are reaching the cooling average expected life of 16-23 years. These all may be a 1-5 year short-term cost expectation, and are listed in the Table -*Opinions of Probable Costs*.

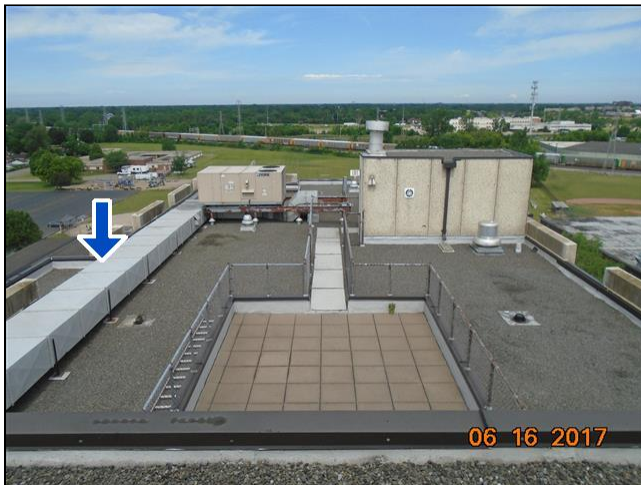
6.0 Item 3(Picture) AHU duct return and supply vents at each end of hallways 3-10-great condition

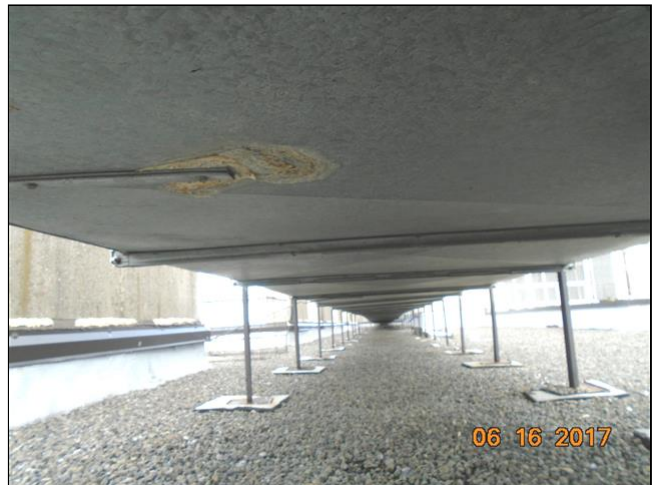
6.0 Item 4(Picture) AHU duct return and supply vents at each end of hallways 3-10-great condition

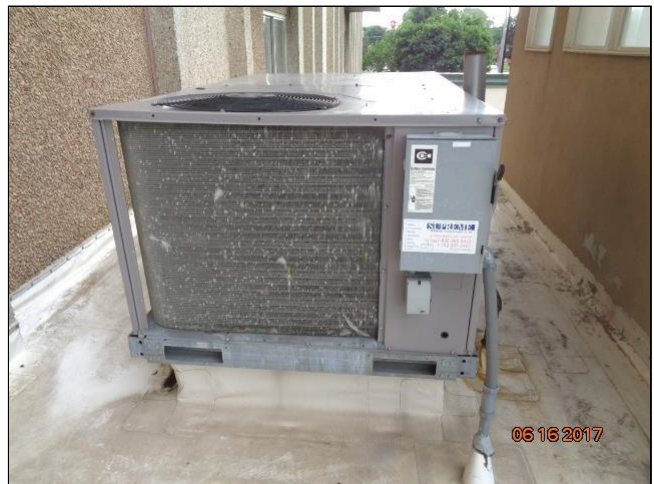
6.0 Item 6(Picture) Lobby area 2002 Carrier may need replacement within the next 1-5 yrs

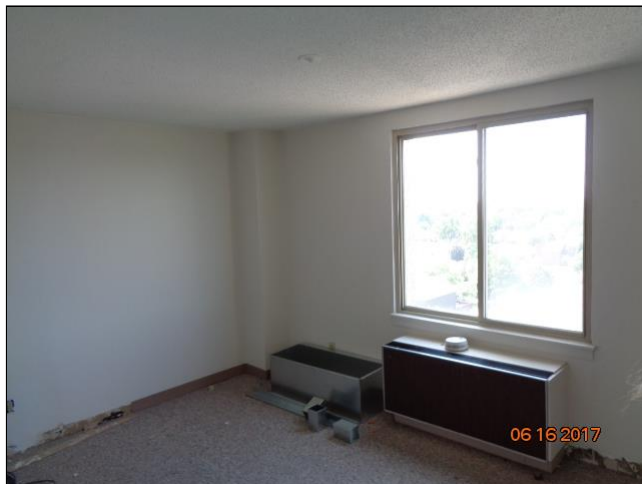
6.0 Item 8(Picture) The framework for the new Amana replacement needs to be retrofitted to adapt to the smaller new units.

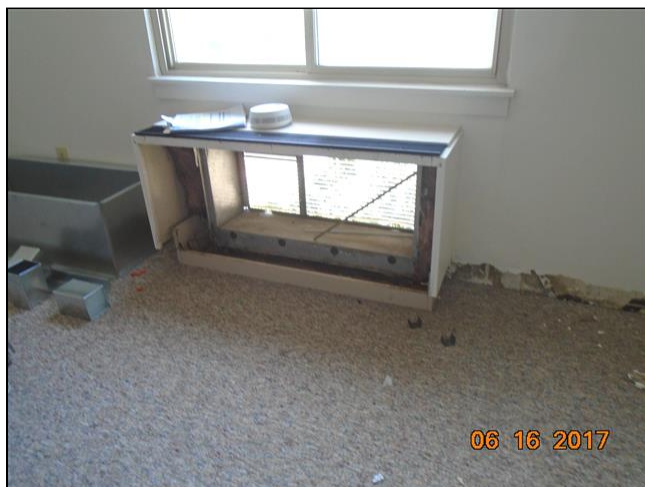
6.0 Item 9(Picture) The framework for the new Amana replacement needs to be retrofitted to adapt to the smaller new units.

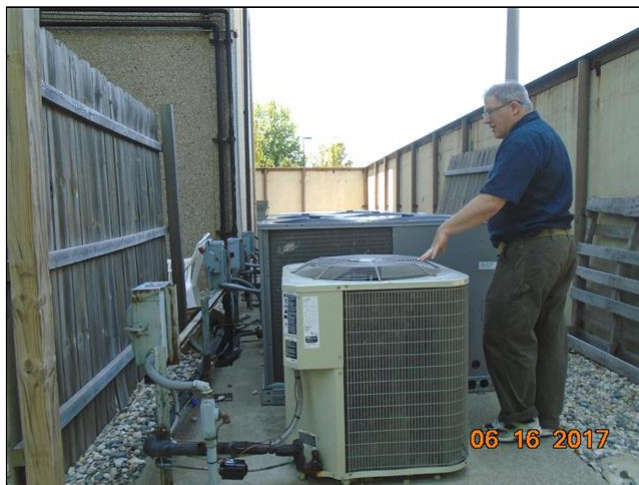
The average life of cooling components (compressor's, evaporator coils, condensers) are 16-23 years. Sometimes it is more cost effective to replace the whole system rather make costly repairs. Two of these condensers (2 TON) are currently at 17 and 19 years. Plan for replacement within the next 1-5 years.

6.0 Item 11(Picture) Outside air condenser fins were clogged, and had hail damage.

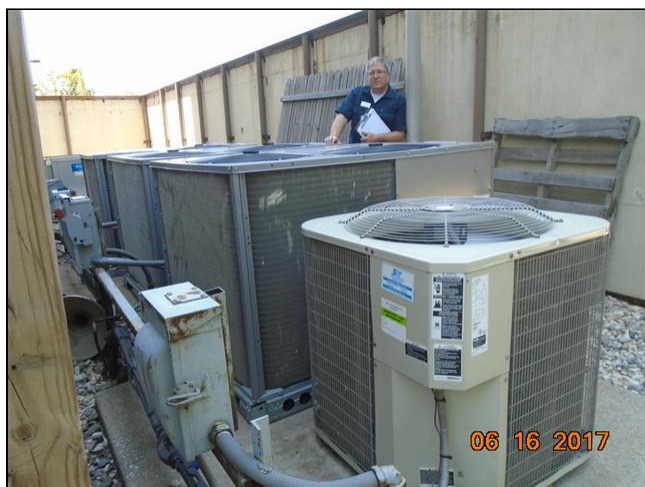
6.0 Item 12(Picture) Outside air condenser fins were clogged, and had hail damage.

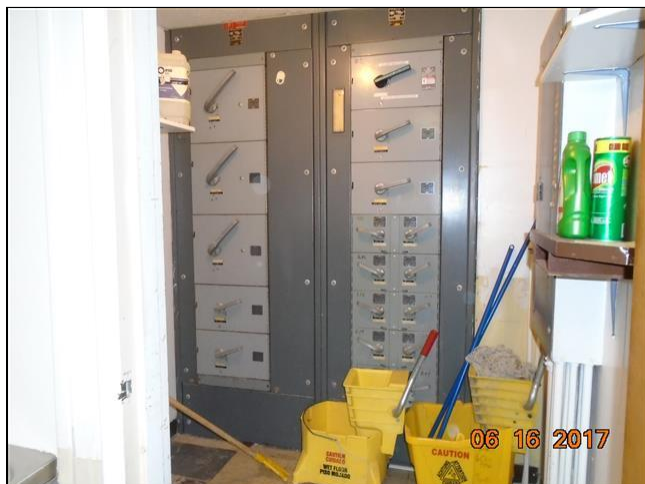
**CONCERNS:** The 47 year-old switch boards are considered aged. Each 200 AMP supply switch gear shuts-off a vertical column of resident electric panels. Aged switchgear can stick, contact with needed shut-off components can become inoperable. There are a few, and various other electrical maintenance needs throughout the building that should be repaired (open spacing in building electric panels).

7.0 Item 1(Picture) Aged switchboards require a maintenance plan

**RECOMMENDATIONS:** Obtain a licensed electrician to exercise, clean, and lubricate switchgear. Create an annual electrical maintenance plan on the aging system.

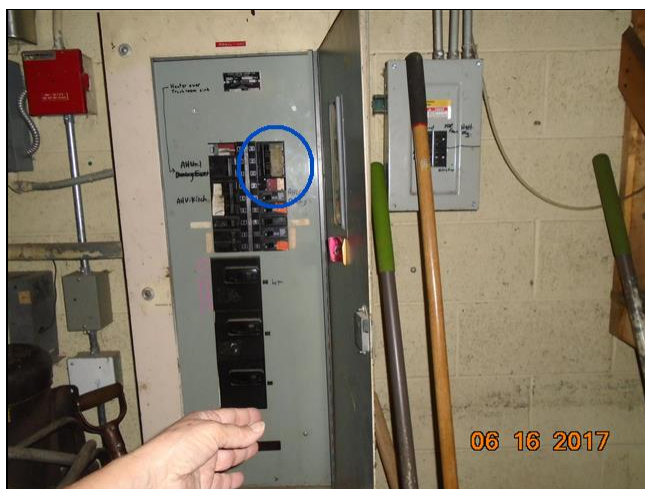
7.0 Item 3(Picture) One-two panels needed servicing.

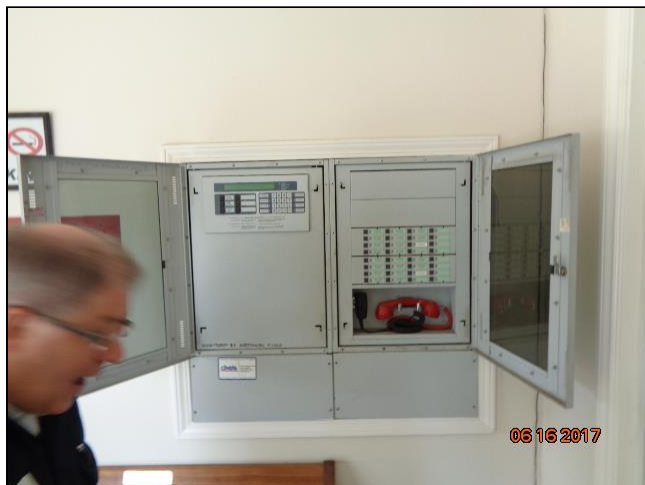
8.0 Item 1(Picture) Basic alarm control center requires stall location of triggered smoke alarm

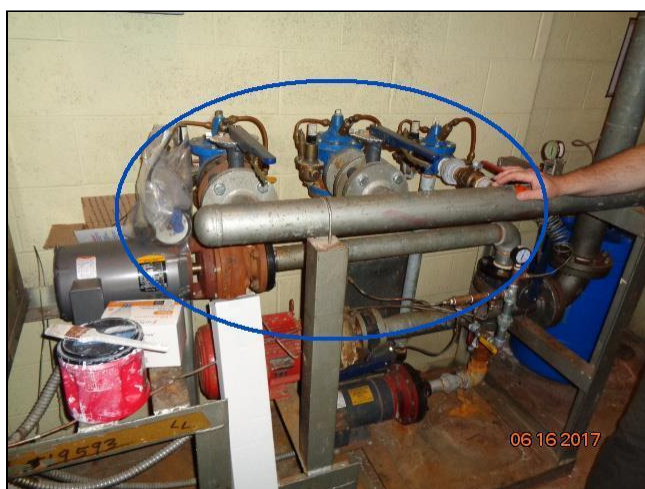
8.0 Item 3(Picture) Three new Pumps to send sprinkler to upper floors

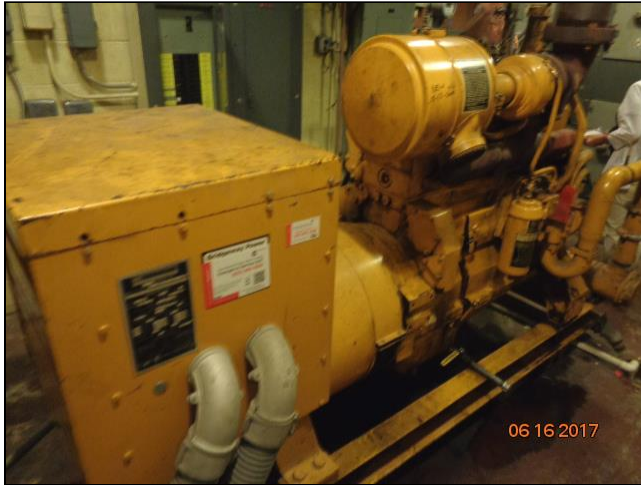
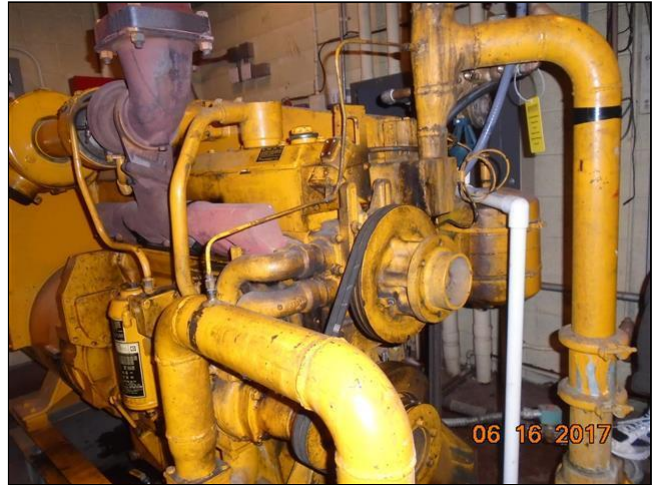
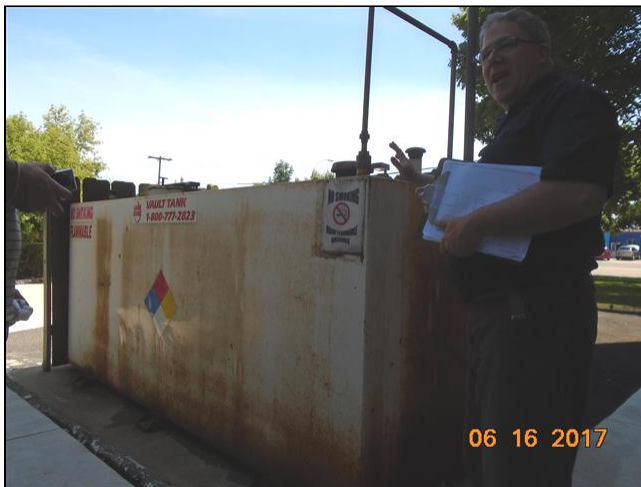
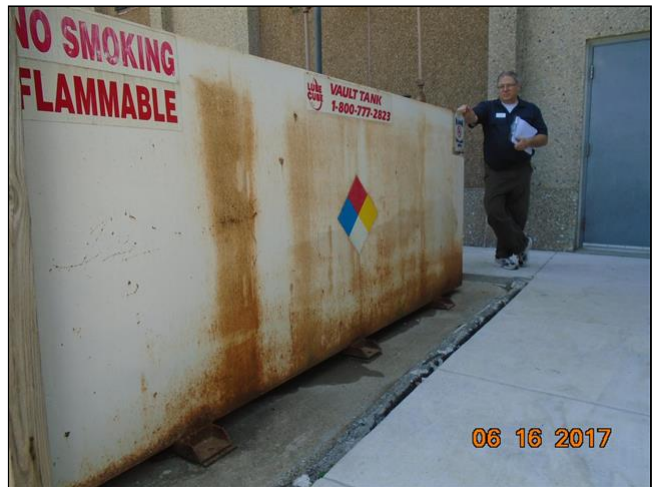
The generator fuel tank is double walled, and approximately 1000 gallon diesel above ground tank. It is rusting/aged. There is an inner tank with an unknown condition.

**CONCERNS:** There were puddles (type of liquid unknown) on the floor under the emergency generator. It is in need of maintenance. The last inspection was completed two years ago, and the generator requires an annual inspection. It appears to be the original 1971 generator, although the actual date is unknown. The above ground diesel fuel tank is rusting. The inner tank condition is unknown

**RECOMMENDATIONS:** An inspection and maintenance is already scheduled within the next couple of weeks. It may be feasible to have the generator assessed by Cummins Bridgeway, LLC (current servicer) for a recommendation, or benefits of replacing the 40+ year old generator.

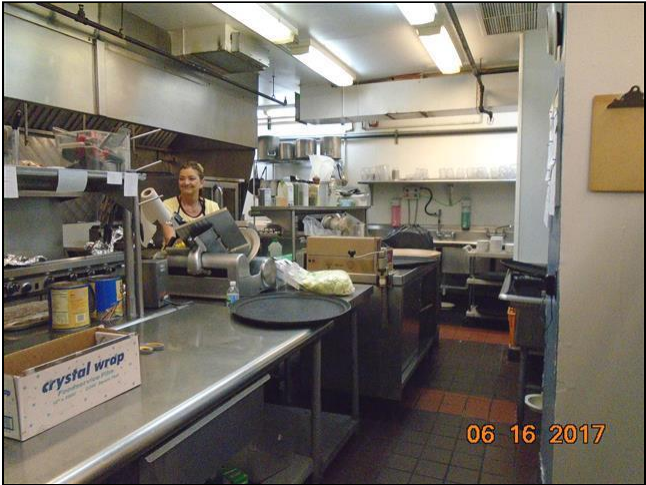
9.0 Item 20(Picture) Kitchen fire-safety is up to date

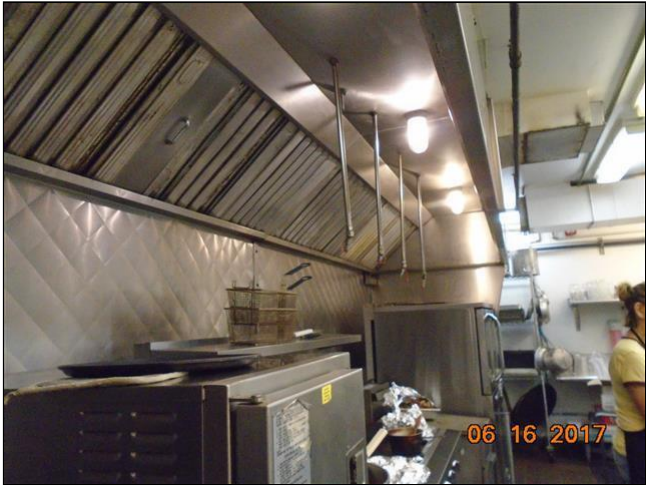
9.0 Item 21(Picture) Kitchen fire-safety is up to date
