# Property Condition Report

## Prepared For: Commercial Sample

## Prepared By: Minnesota Building Inspections

**Date of Inspection:** 6/16/2017

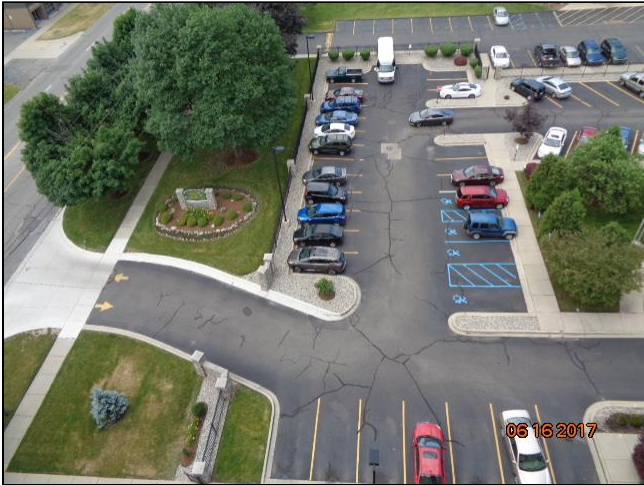
3.0 Item 1(Picture) New Allen Road entry

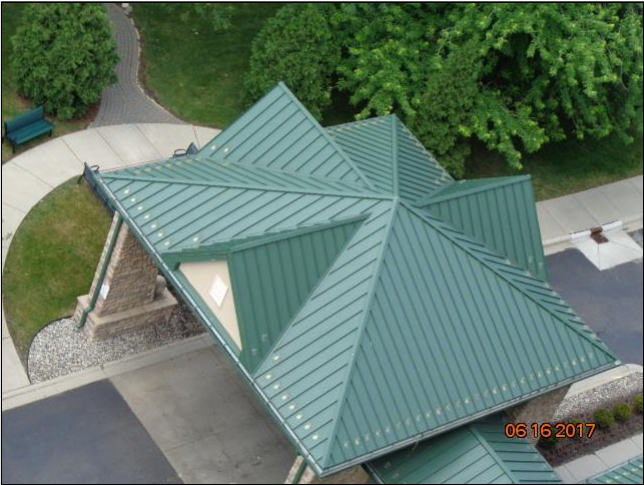
3.0 Item 2(Picture) Covered drive-through

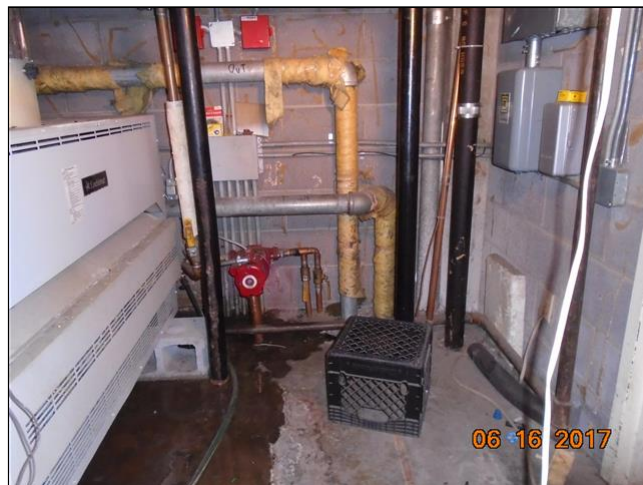
5.1 Item 2(Picture)

5.1 Item 1(Picture) Water on floor below Lochnivar boiler- needs service

**RECOMMENDATIONS:** Have both boilers serviced, and repair as needed.

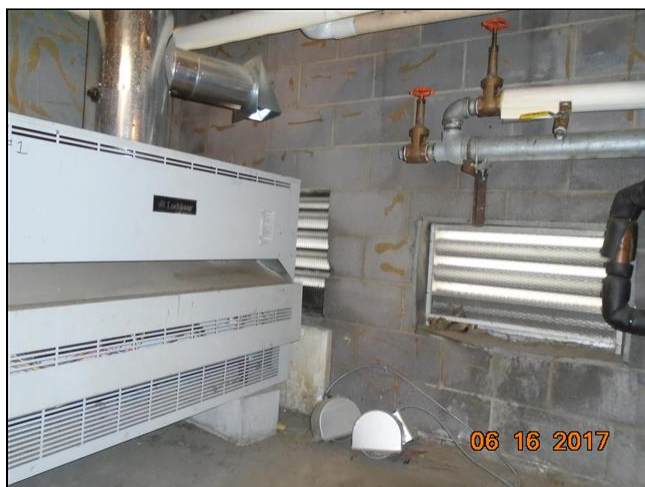
5.1 Item 3(Picture) 2nd boiler

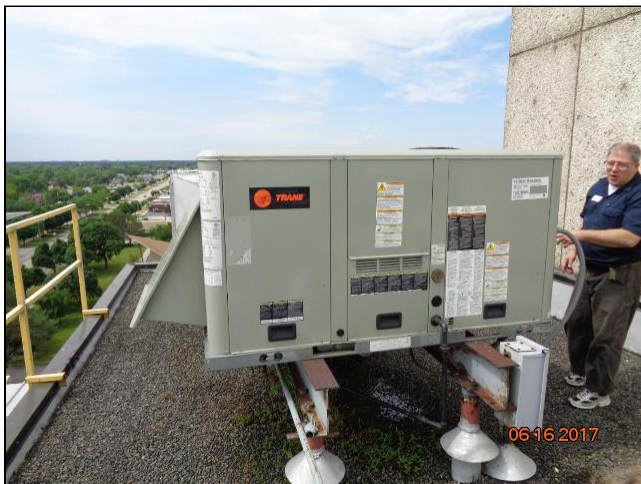
6.0 Item 5(Picture) 2012 5 TON Trane-serves penthouse

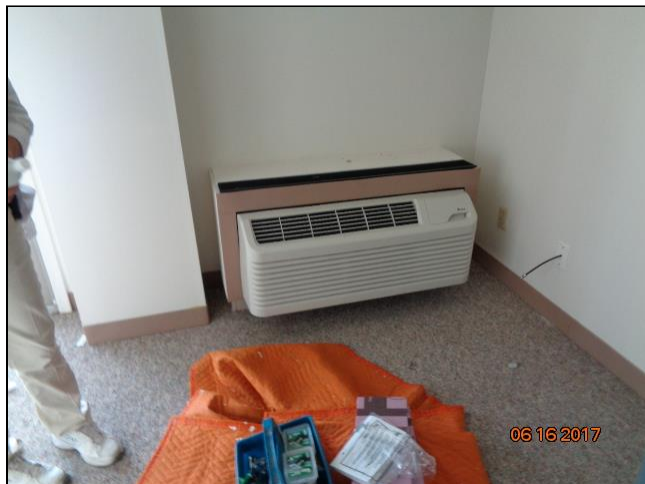
6.0 Item 7(Picture)

The resident rooms (145) and various other rooms, and office spaces are being heated and cooled by packaged terminal air conditioners (PTAC ) through-wall units. About 1/2 of 200+ units have been replaced. Expect to replace about 100 more units over the next 5 years.

The framework for the new Amana replacement needs to be retrofitted to adapt to the smaller new units.

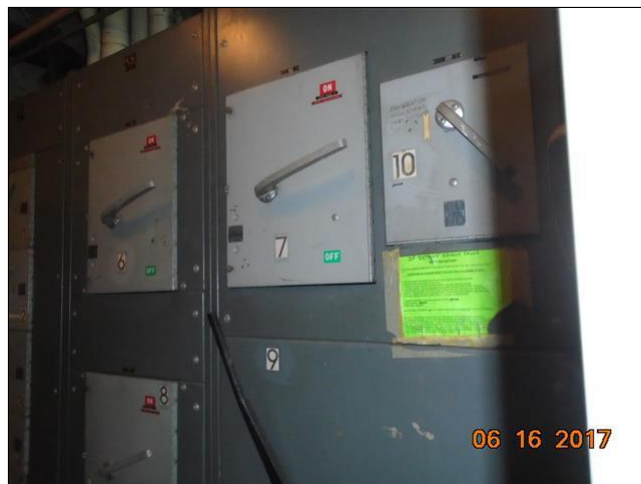
7.0 Item 2(Picture) Aged switchboards require a maintenance plan

**RECOMMENDATIONS:** Obtain a licensed electrician to exercise, clean, and lubricate switchgear. Create an annual electrical maintenance plan on the aging system.

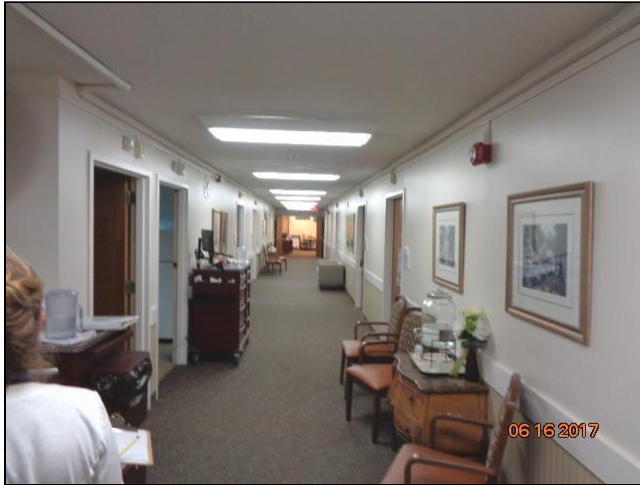
9.0 Item 12(Picture) Third party managed assisted living - floor 2

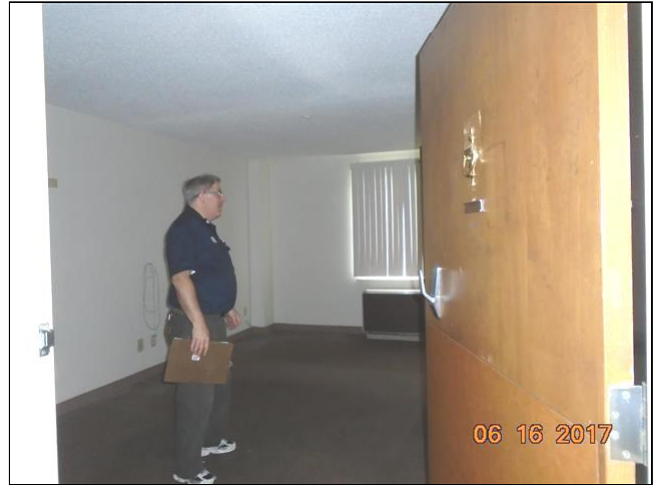
9.0 Item 13(Picture) 2nd floor assisted living

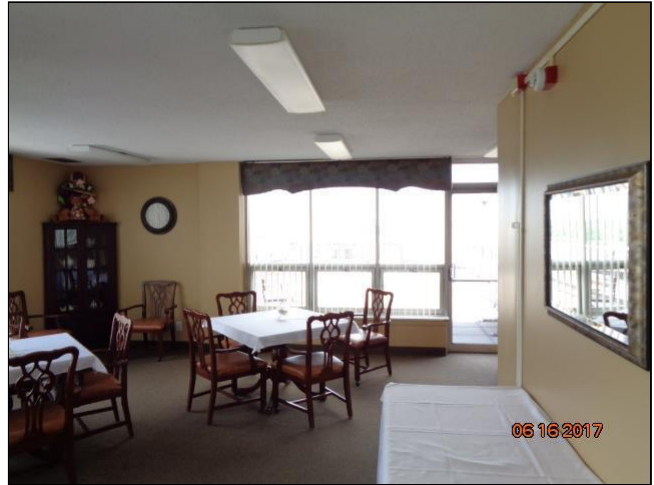
9.0 Item 17(Picture) 11th floor Penthouse dining

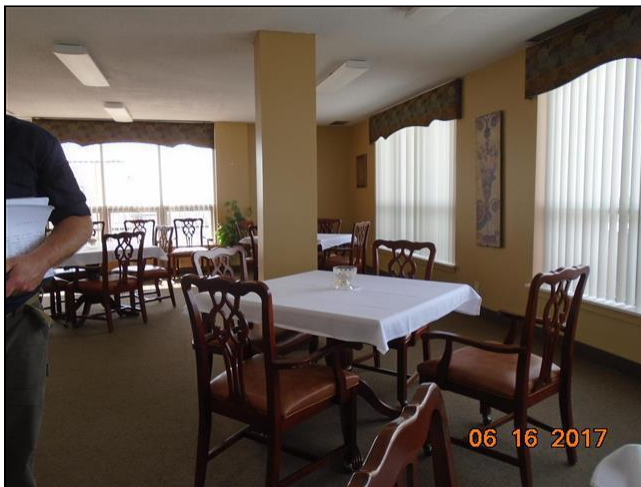
9.0 Item 18(Picture) 11th floor Penthouse dining

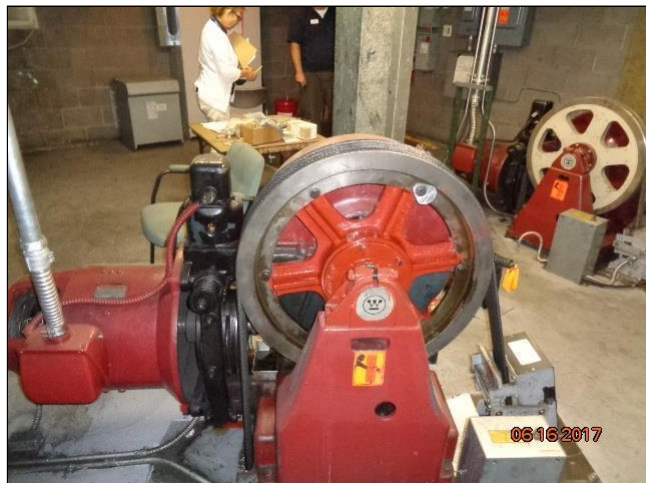
9.0 Item 19(Picture) New cables and other updates

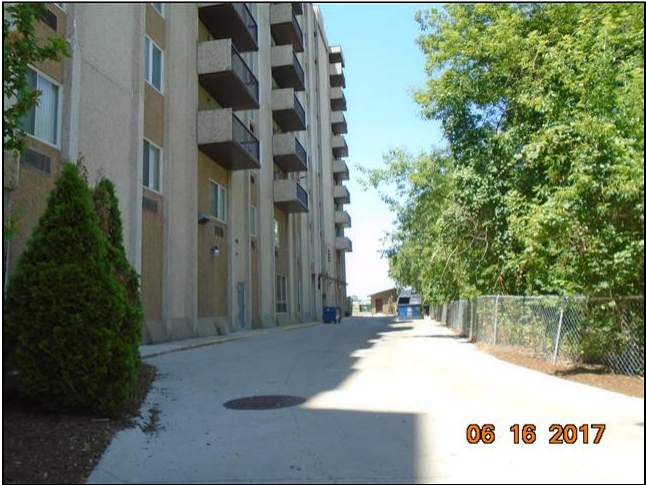
9.0 Item 24(Picture) Back of building
